## VEHICLE INSPECTION REPORT

**YK70EFZ**

### Mercedes-Benz Sprinter 3.5t H2 Progressive Van

**Non Runner**  
Inspection

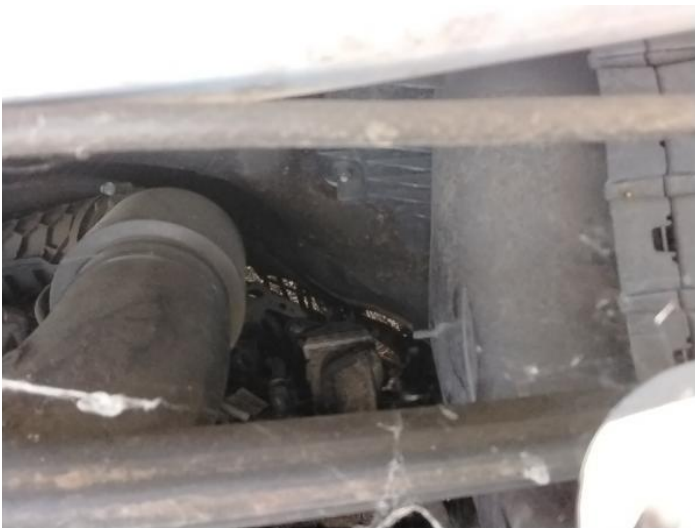
1: Unclassified  
Major Parts Missing  
Report Only

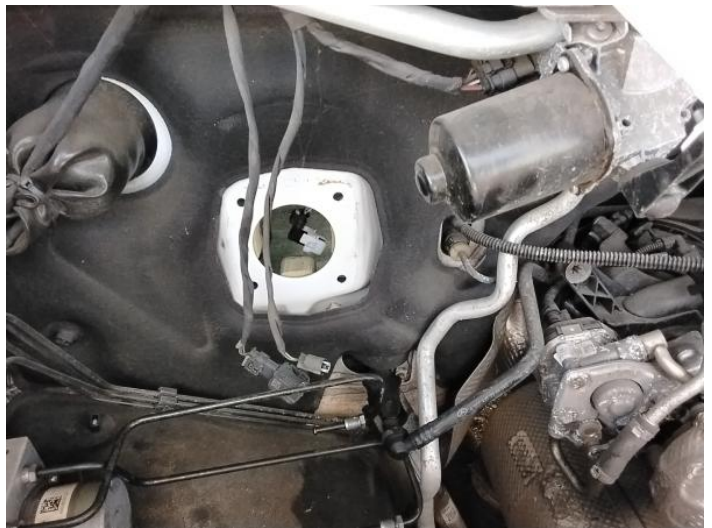
2: Unclassified  
Major Parts Missing  
Report Only

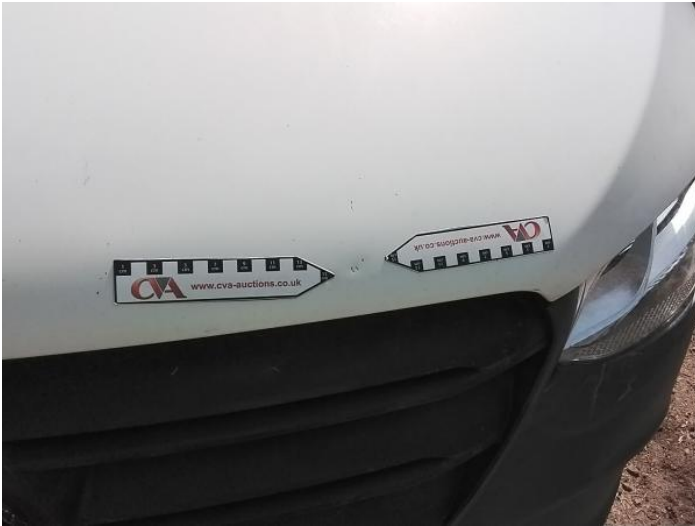
3: Bonnet  
Dented  
With Paint Damage

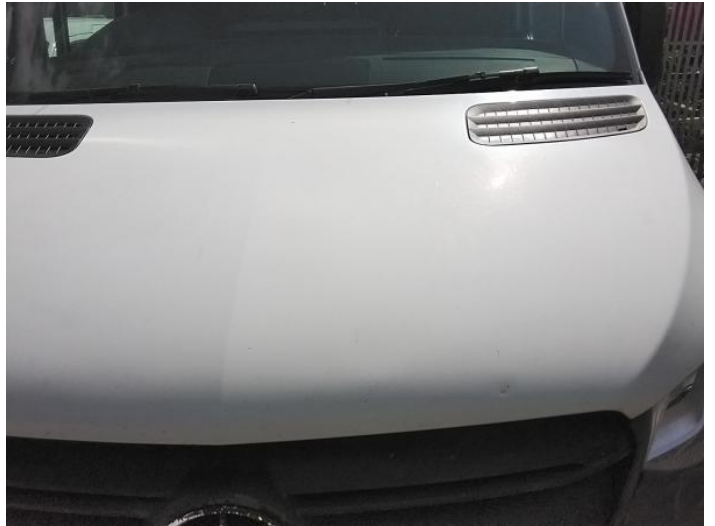
4: Bonnet  
Chipped  
Multiple Chips

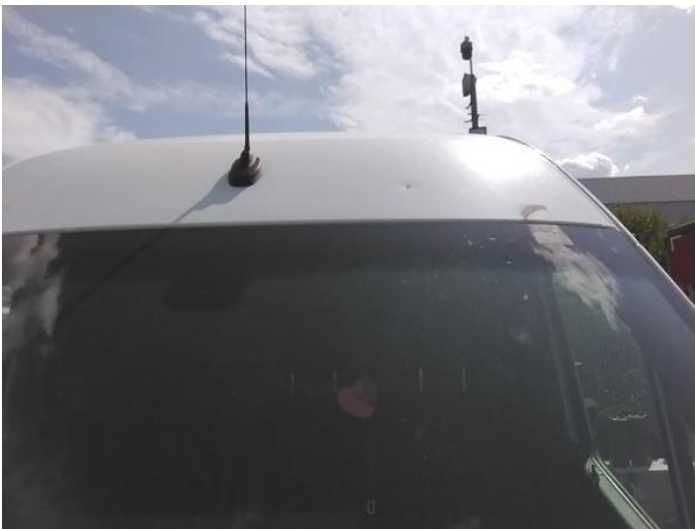
5: Roof  
Dented  
With Paint Damage

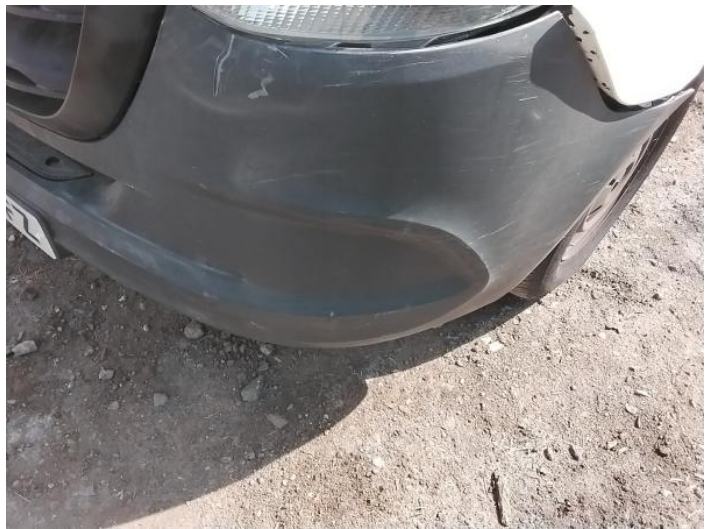
6: Bumper Front  
Scratched  
Over 100mm Thru Paint

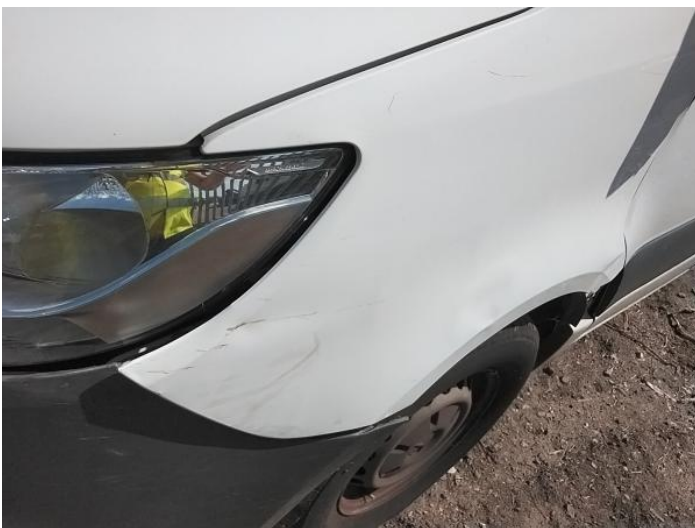
7: Wing nsf  
Dented  
With Paint Damage

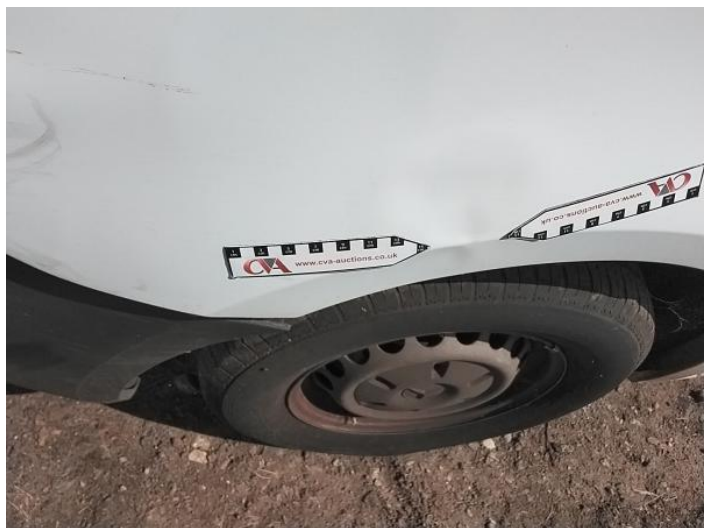
8: Wing nsf  
Dented  
Over 30mm

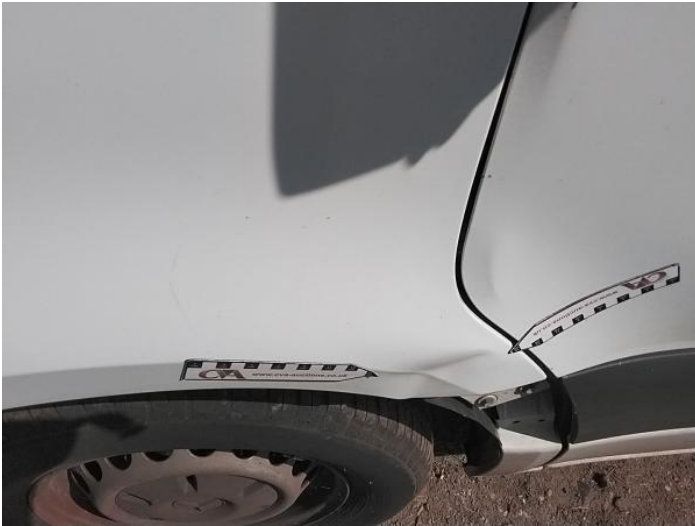
9: Wing nsf  
Dented  
Over 30mm

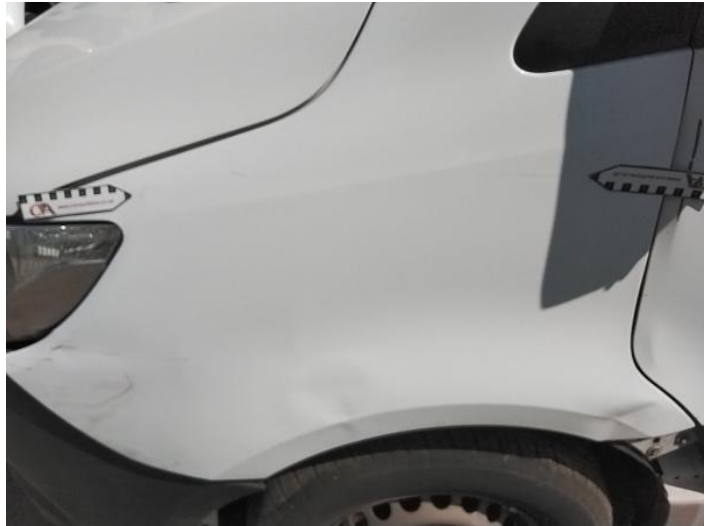
10: Wing nsf  
Scratched  
Over 25mm Thru Paint

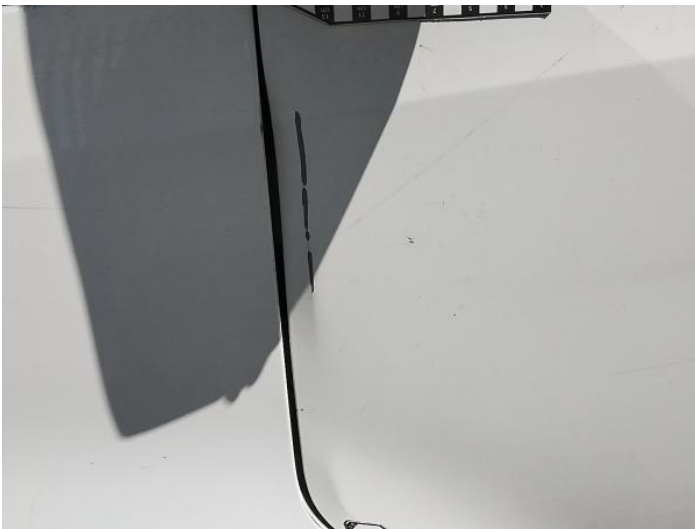
11: Door nsf  
Dented  
With Paint Damage

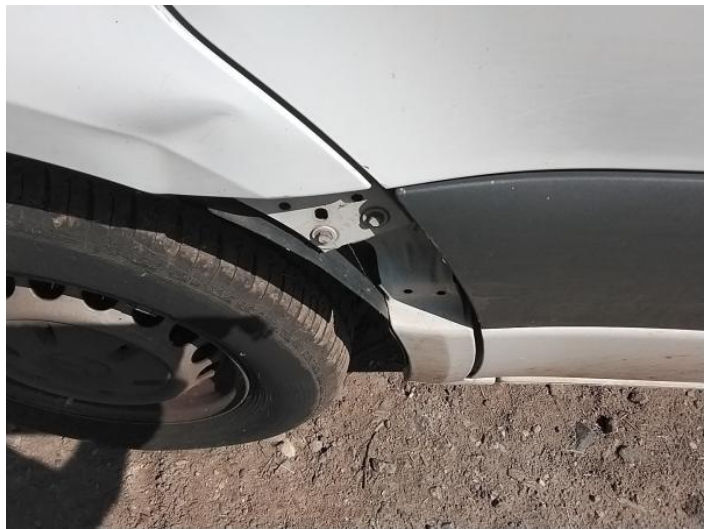
12: Door Moulding nsf  
Missing  
Replace

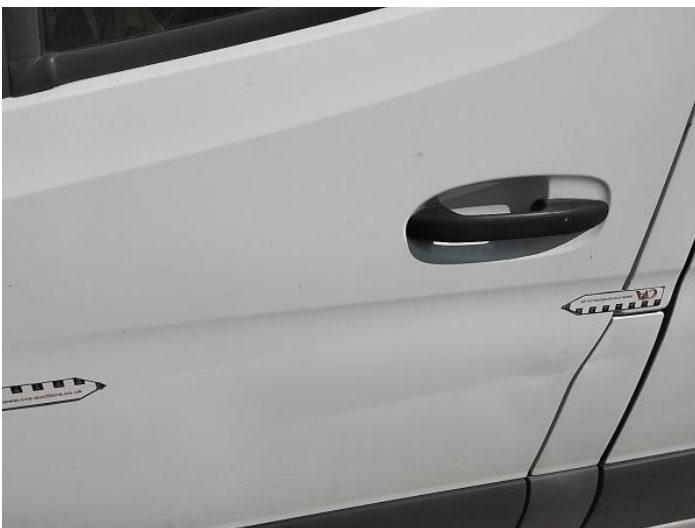
13: Door nsf  
Dented  
Over 30mm

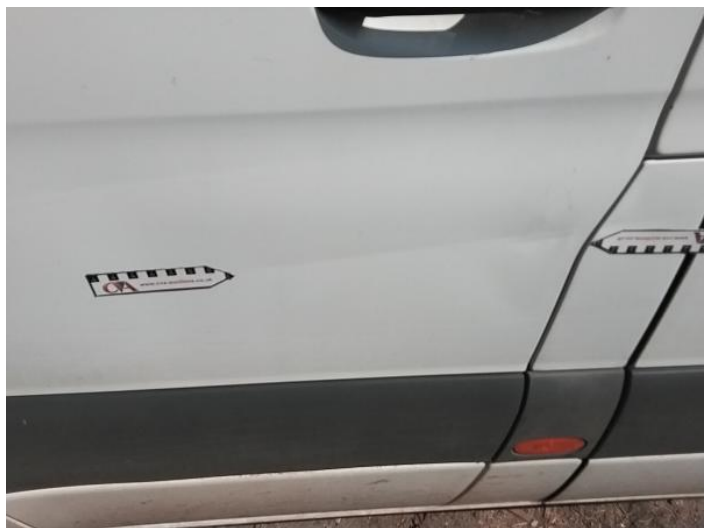
14: Door nsf  
Dented  
Over 30mm

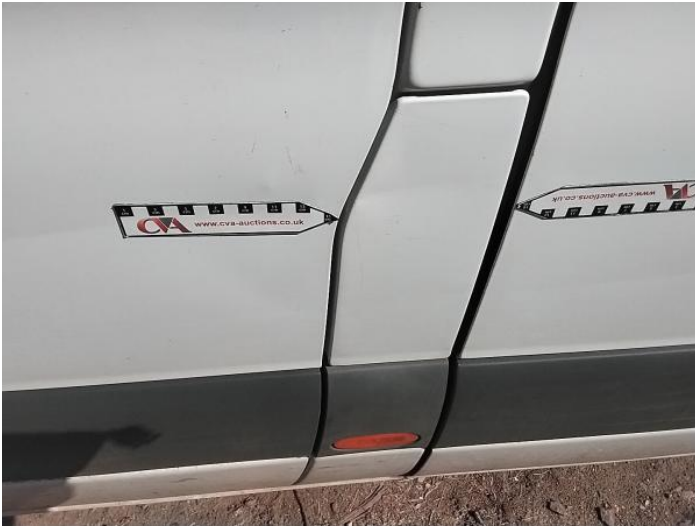
15: B Post ns  
Dented  
Over 30mm

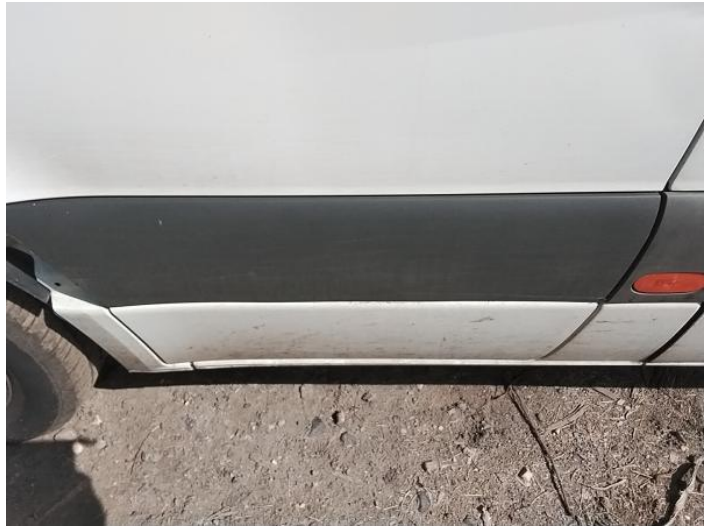
16: Door Moulding nsf  
Scuffed (Unpainted)  
Over 100mm

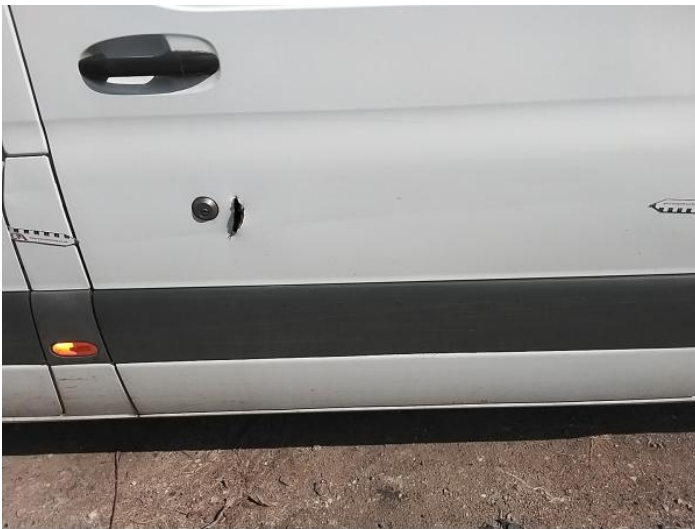
17: Qtr Panel nsr  
Dented  
Over 30mm

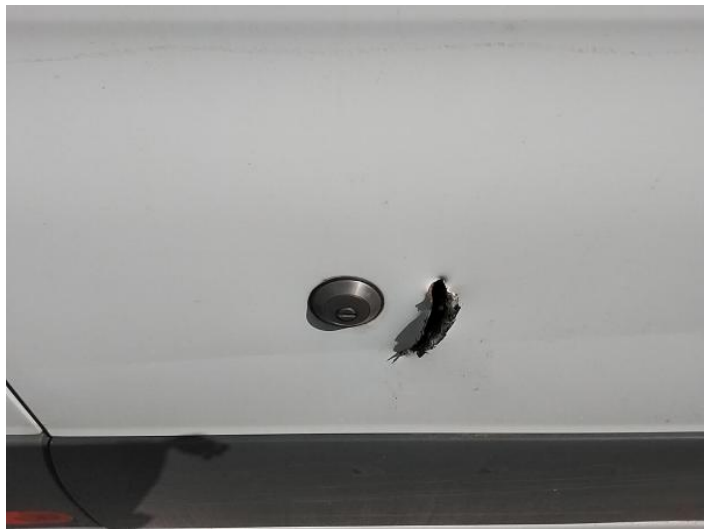
18: Qtr Panel nsr  
Hole  
Over 10mm

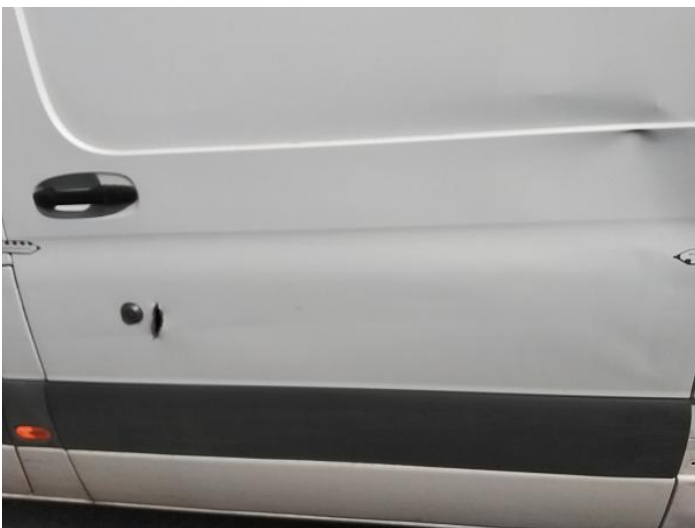
19: Qtr Panel nsr  
Scratched  
Over 25mm Thru Paint

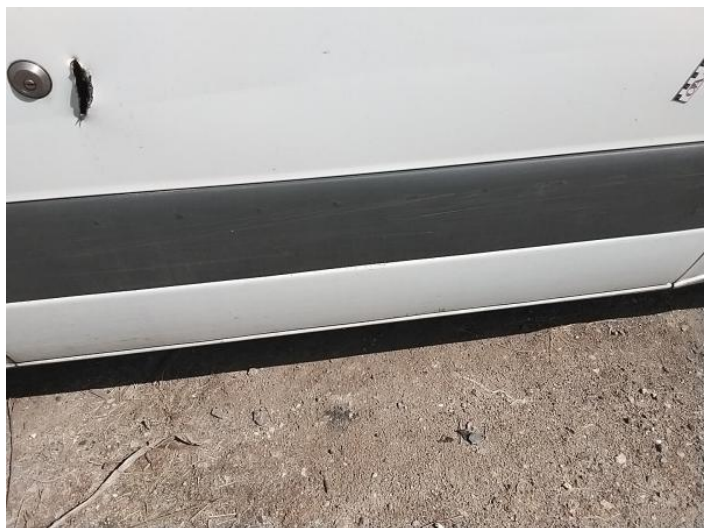
20: Qtr Panel Moulding ns  
Scuffed (Unpainted)  
Over 100mm

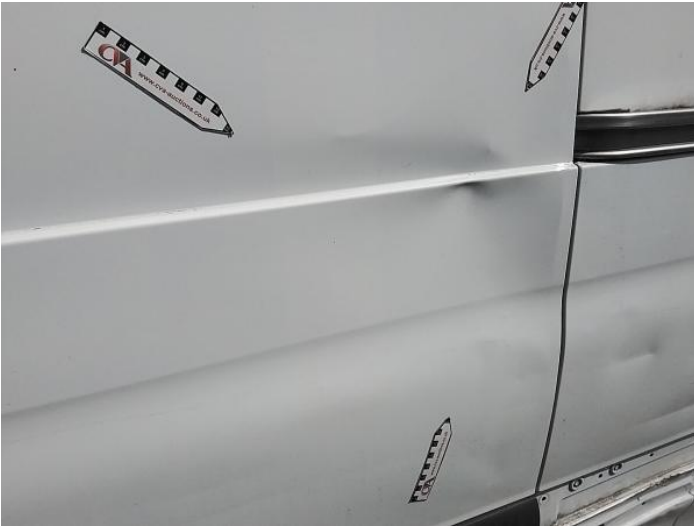
21: Qtr Panel nsr  
Dented  
Over 30mm

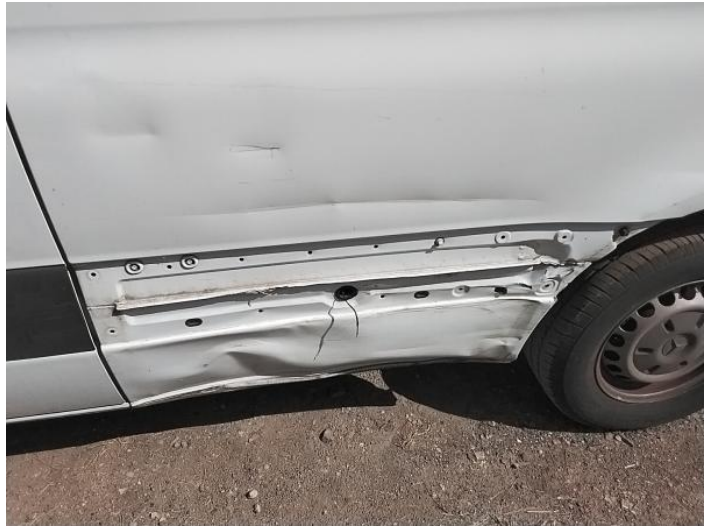
22: Unclassified  
Substantial Accident Damage  
Report Only

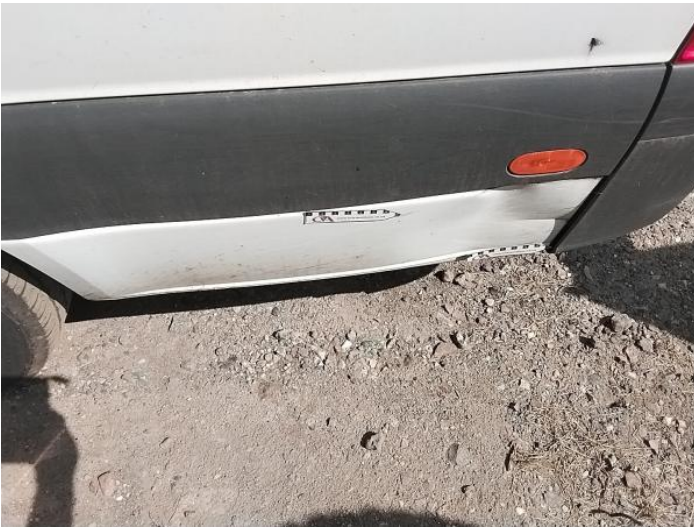
23: Qtr Panel nsr  
Dented  
Over 30mm

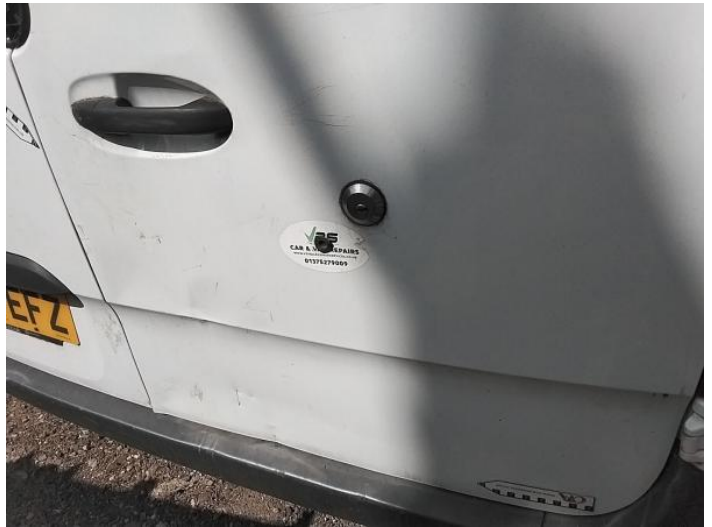
24: Door osr  
Dented  
With Paint Damage

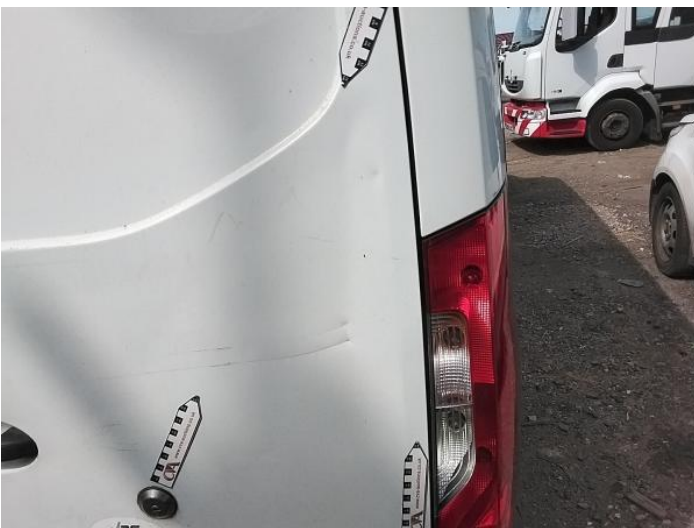
25: Door osr  
Dented  
With Paint Damage

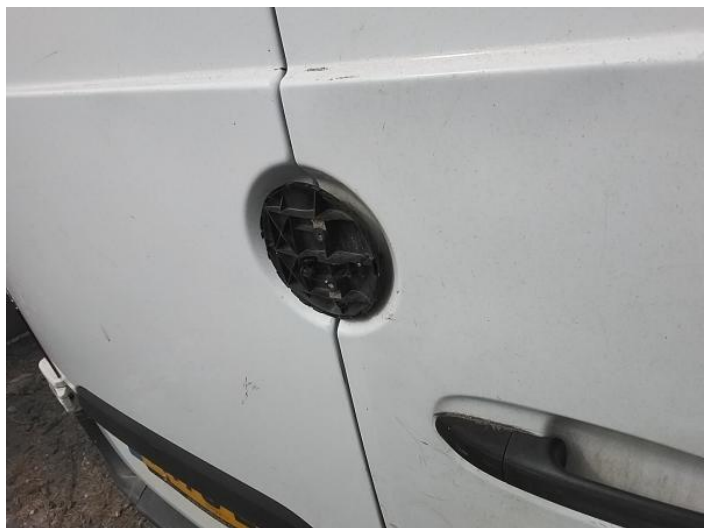
26: Badgedecal Rear  
Broken  
Replace

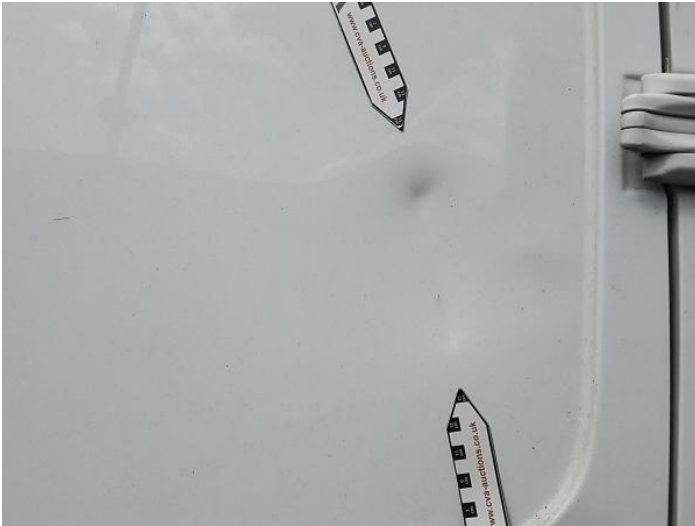
27: Door osr  
Dented  
Over 30mm

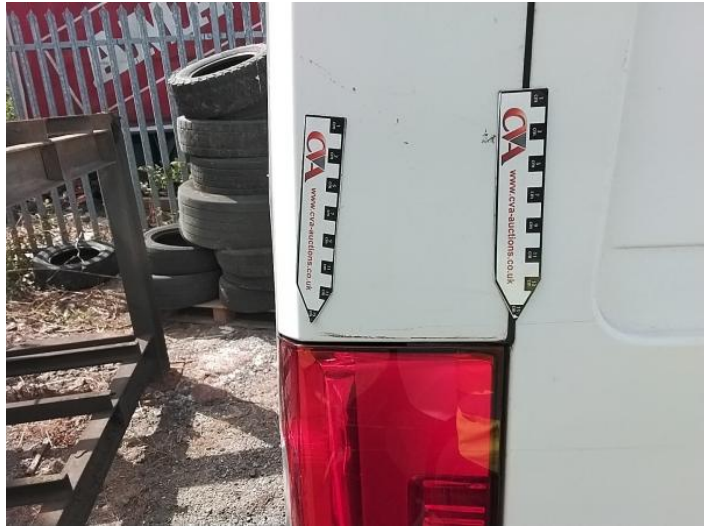
28: C Post os  
Scratched  
Over 25mm Thru Paint

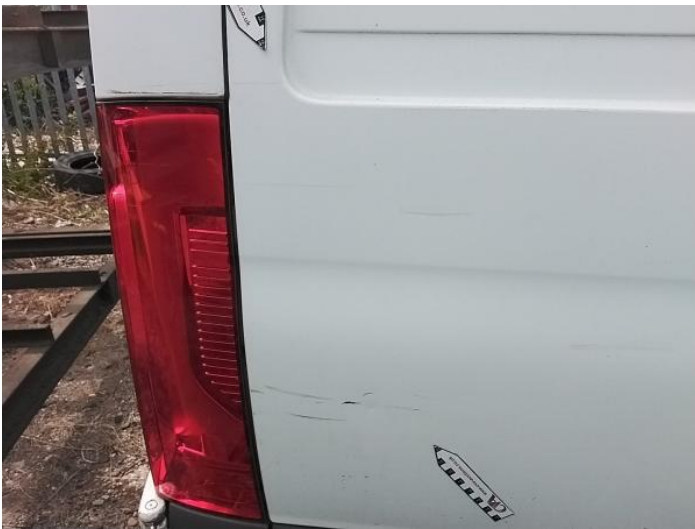
29: Qtr Panel osr  
Scratched  
Over 25mm Thru Paint

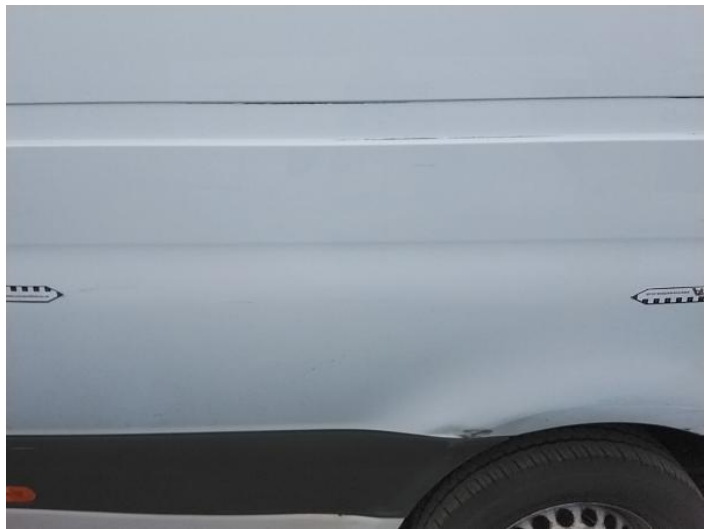
30: Qtr Panel osr  
Scratched  
Over 25mm Not Thru Paint

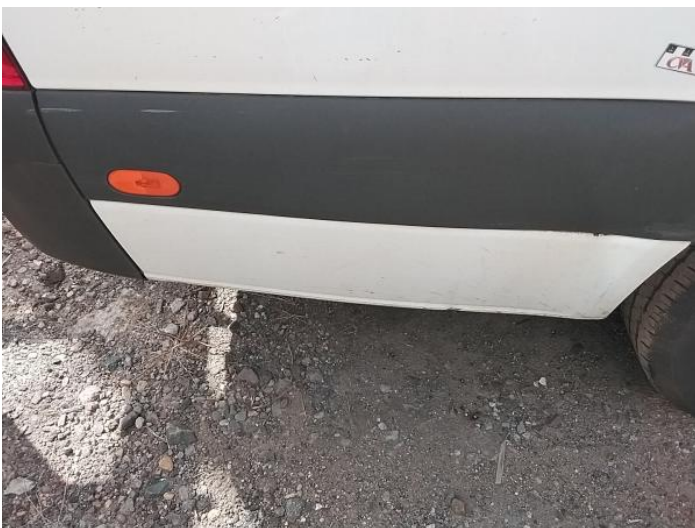
31: Qtr Panel Moulding os  
Scuffed (Unpainted)  
Over 100mm

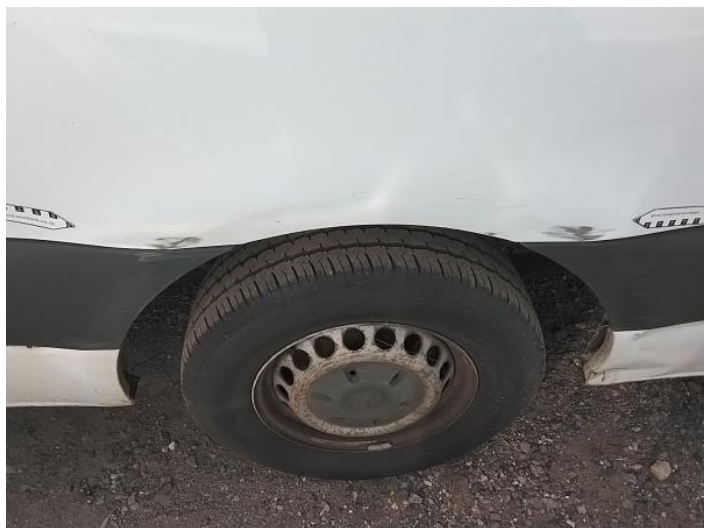
32: Qtr Panel osr  
Dented  
With Paint Damage

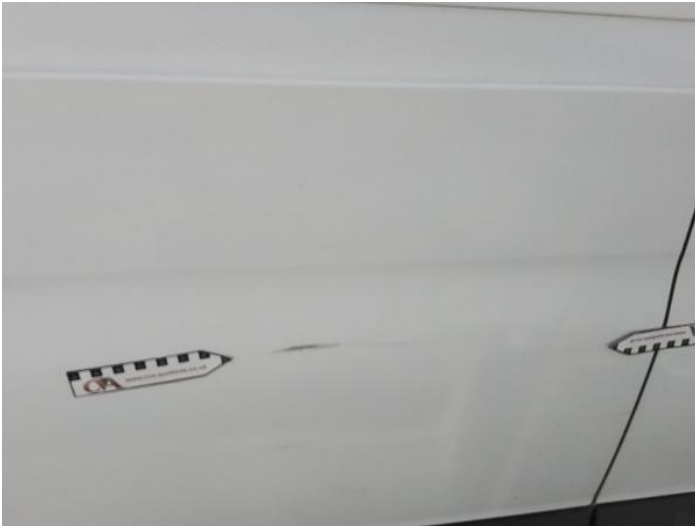
33: Qtr Panel osr  
Scratched  
Over 25mm Thru Paint

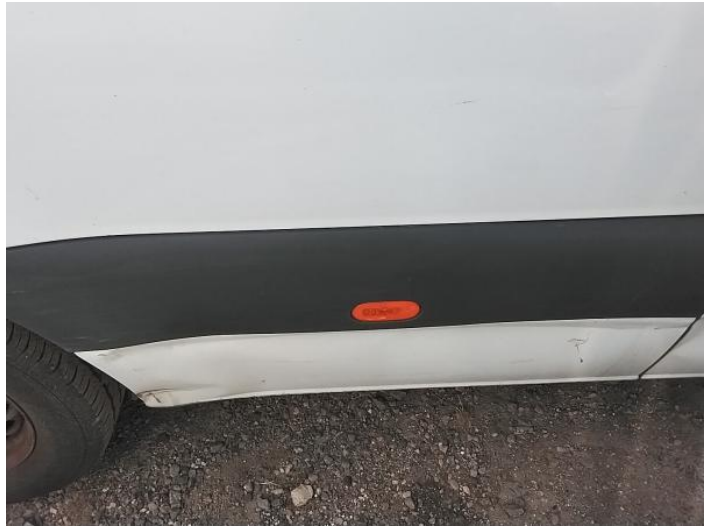
34: Qtr Panel Moulding os  
Scuffed (Unpainted)  
Over 100mm

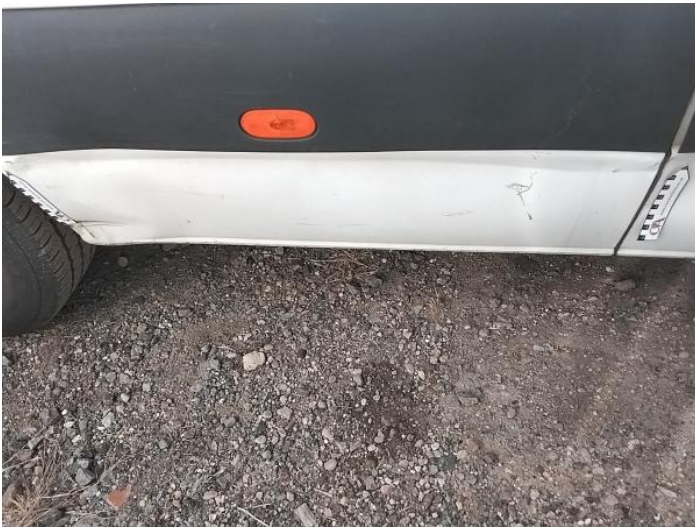
35: Qtr Panel osr  
Dented  
With Paint Damage

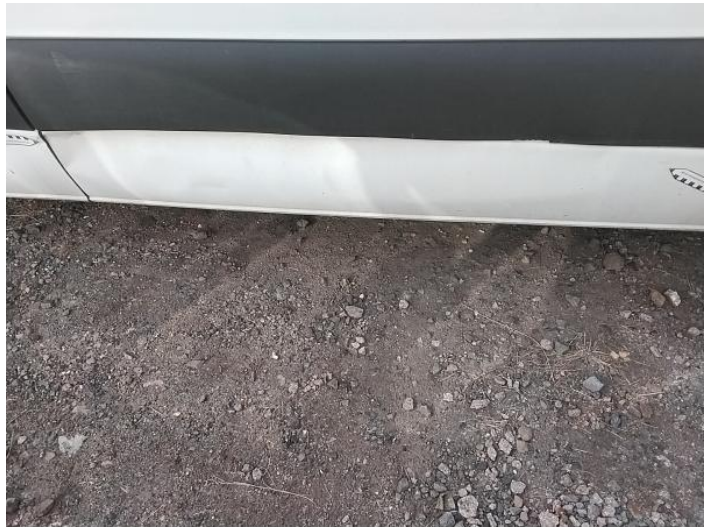
36: Qtr Panel osr  
Dented  
Over 30mm

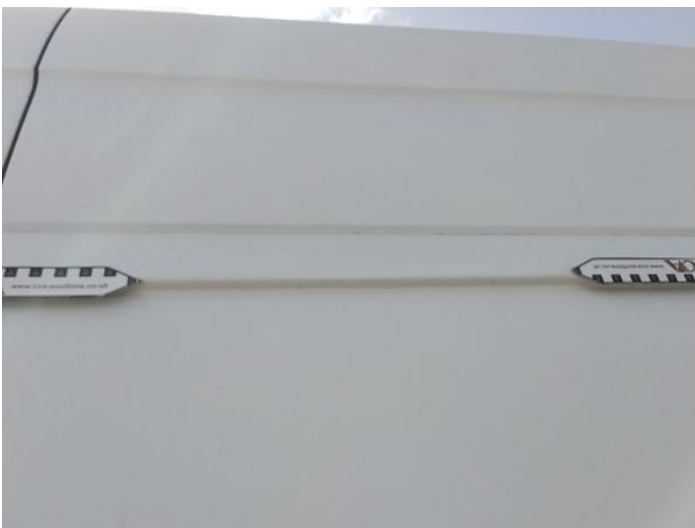
37: Qtr Panel osr  
Dented  
Over 30mm

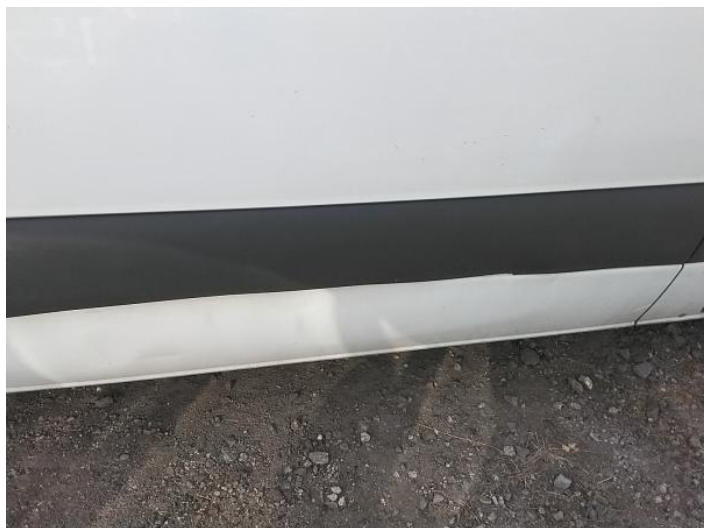
38: Qtr Panel Moulding os  
Broken  
Replace

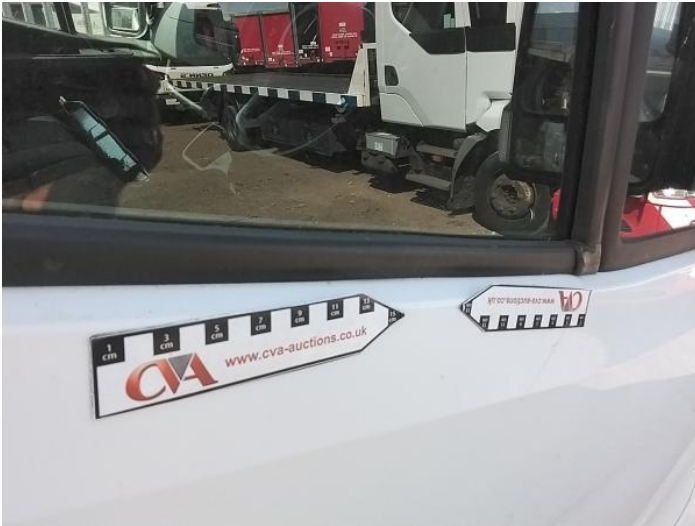
39: Door osf  
Dented  
Over 30mm

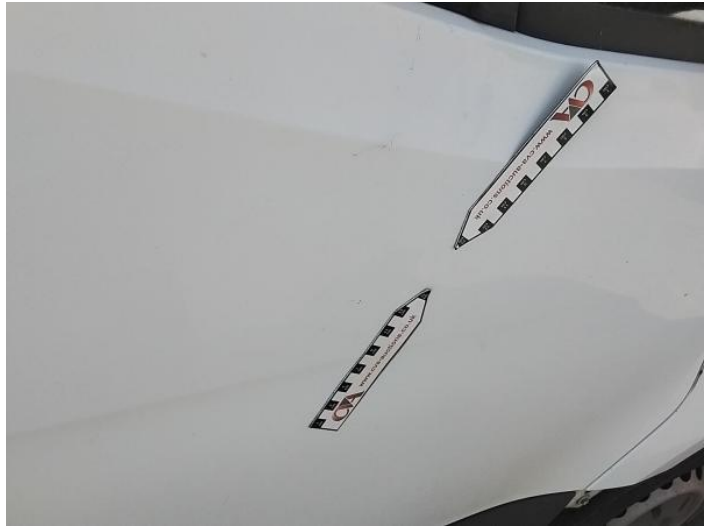
40: Door osf  
Dented  
Over 30mm

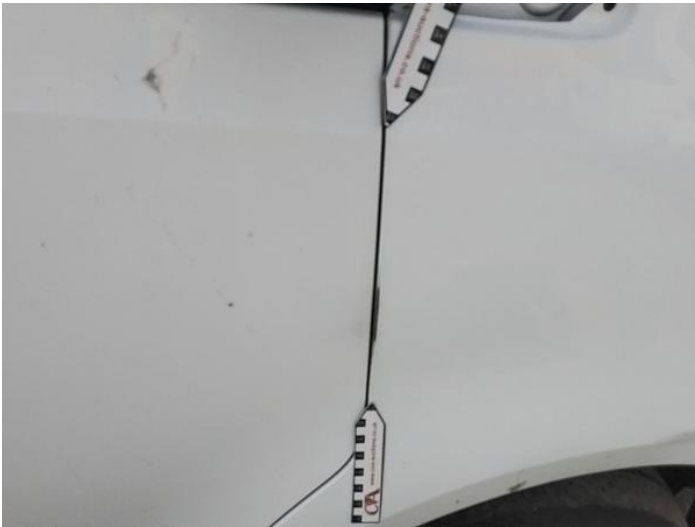
41: Door osf  
Dented  
With Paint Damage

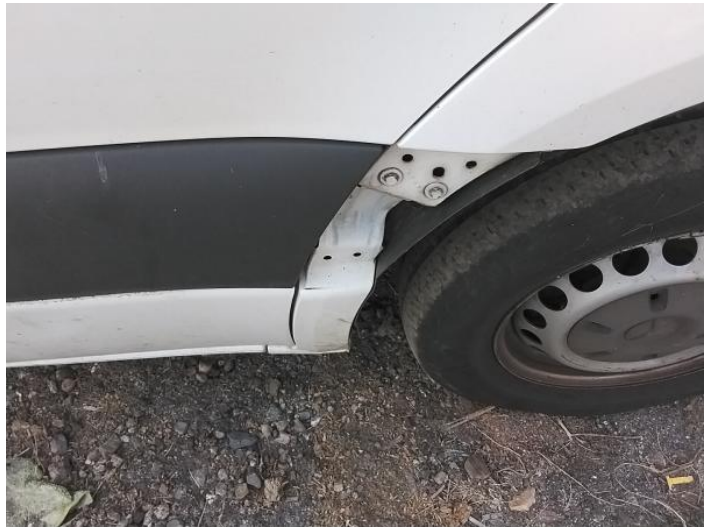
42: Door Moulding osf  
Missing  
Replace

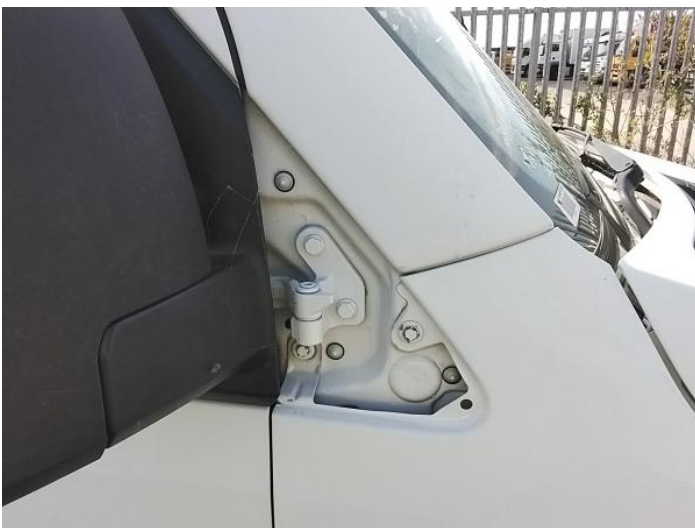
43: Door Moulding osf  
Missing  
Replace

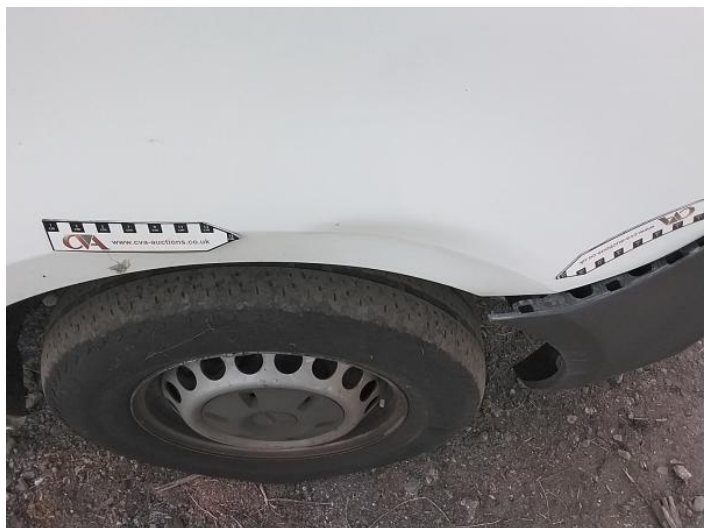
44: Wing osf  
Dented  
Over 30mm

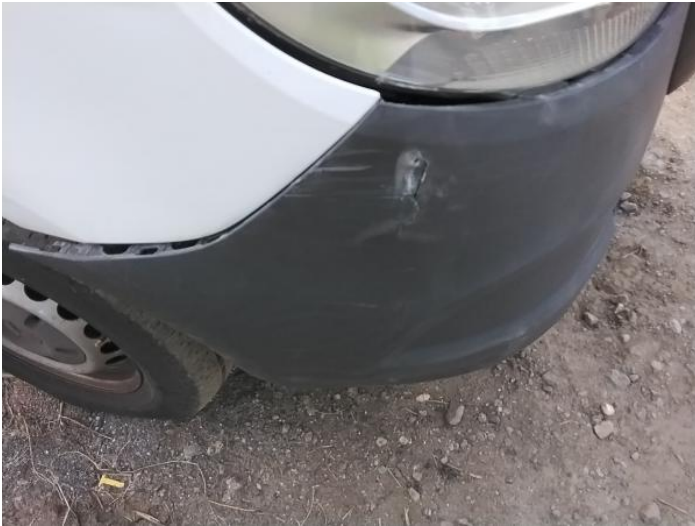
45: Bumper Front  
Hole  
Over 25mm

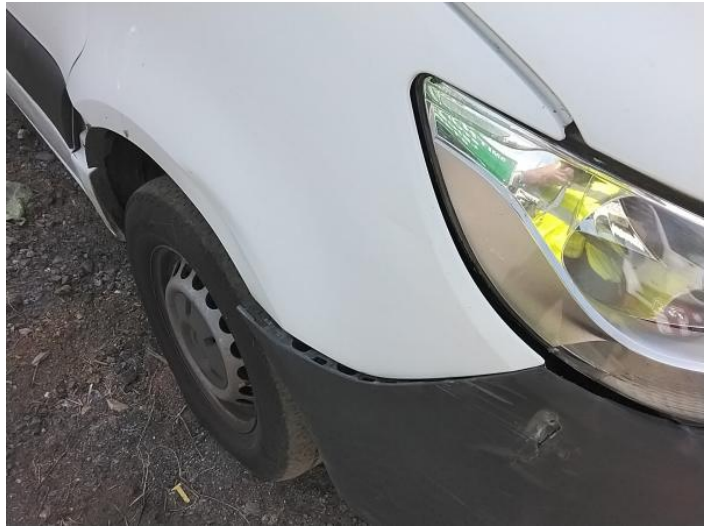
46: Wing osf  
Dented  
Over 30mm

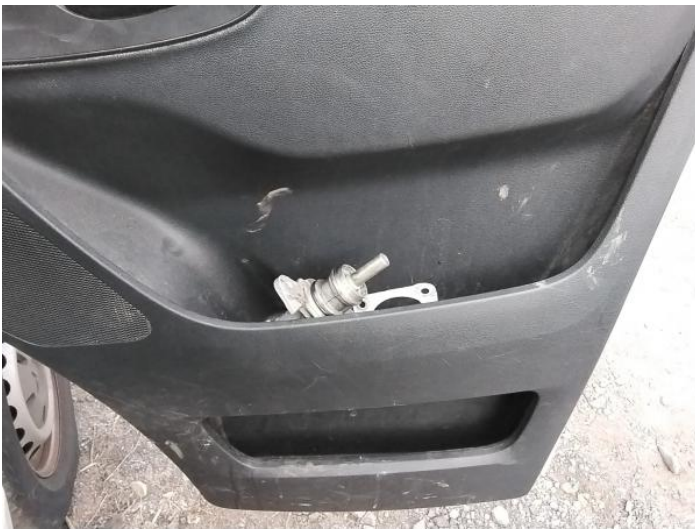
47: Door Pad osf  
Soiled  
Heavy

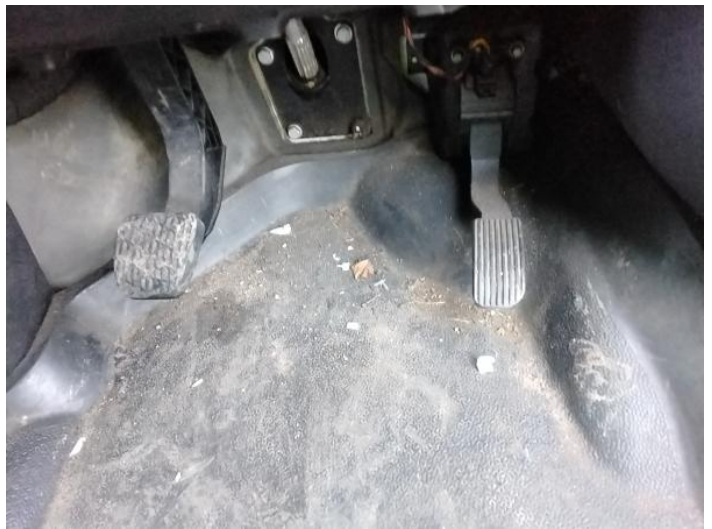
48: Switches And Controls  
Missing  
Replace

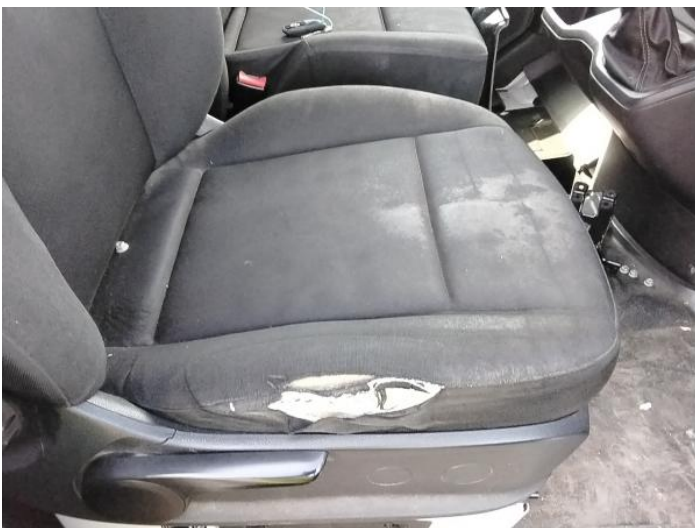
49: Seat Base Cover osf  
Torn  
Over 3mm

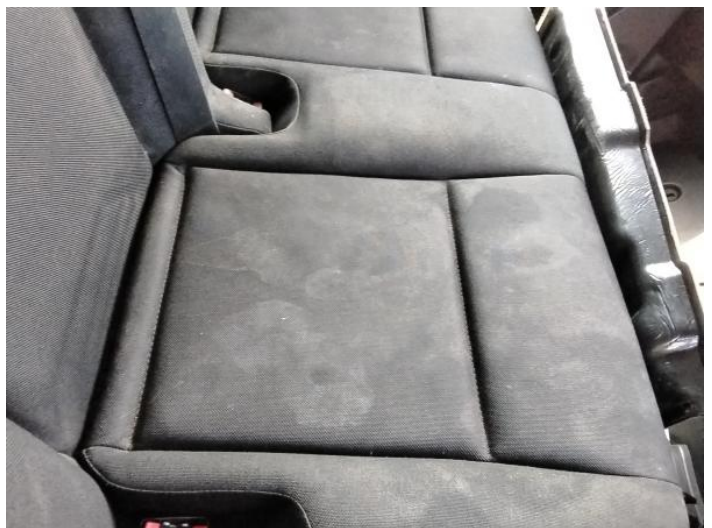
50: Seat Base Cover nsf  
Soiled  
Heavy
